SUMMARY OF FIVE YEARS OF ALTITUDE TESTING OF THE APOLLO SERVICE MODULE ENGINE IN ALTITUDE TEST CELL (J-3)

G. H. Schulz ARO, Inc.

October 1969

ROCKET TEST FACILITY

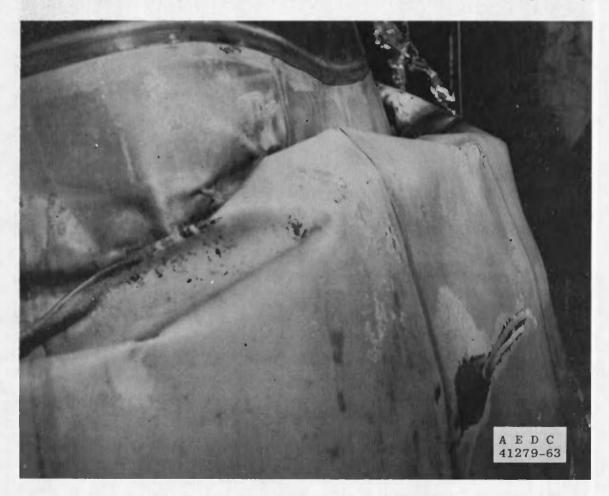
The second nozzle extension configuration (Configuration II, Fig. 5b) was constructed of columbium from the 6:1 to 20:1 area ratio and titanium alloy from the 20:1 area ratio to the nozzle exit. Three circumferential stiffeners, located in the same manner as on Configuration I, were used for structural reinforcement. The columbium section was implemented because of its higher structural strength at elevated temperatures. This nozzle was expected to be adequately durable, and the design proved to be more durable under normal operating conditions than did Configuration I; however, the new design still did not have sufficient strength to withstand normal operating temperatures. The nozzle failed in the titanium section in a similar manner as Configuration I, after about 97 sec of engine operation (Fig. 7). The circumferential failure of Configuration II occurred just aft of the columbium in the titanium at the 24:1 area ratio. This indicated that the columbium section was satisfactory but that the titanium portion was not strong enough.

Fig. 7 Nozzle Extension Failure, Configuration II

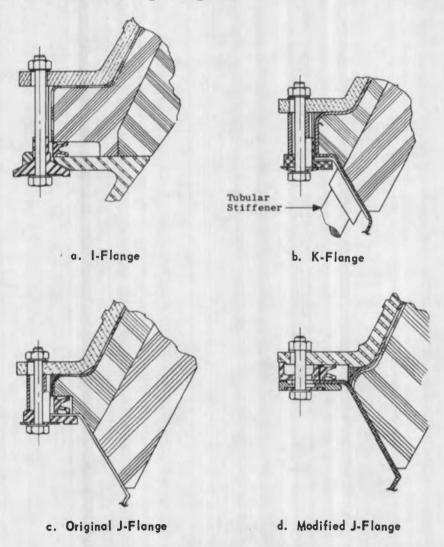
The changes to the combustion chamber/nozzle extension flange are shown in Fig. 12. The original flanges were designated the "I" and "K" types (Figs. 12a and b, respectively), with the former used on the 6:1 area ratio chambers and the latter on the 12:1 chambers. When the nozzle extension was modified from all titanium to the columbium/titanium type (see Section 2.1), the chamber flange design was altered and designated as the J-flange (Fig. 12c). After the nozzle construction proved satisfactory in the interface area, the design was modified to provide a lighter weight configuration, and was designated as the "modified J flange" (Fig. 12d). Additional testing confirmed the adequacy of this design, and it became the approved configuration which was used on all engines in Phases II through VI. The only other difficulty encountered with this flange design was during Phase V when a bond separation occurred at the chamber flange (Fig. 13).

Fig. 12 Chamber/Nozzle Extension Flange Designs

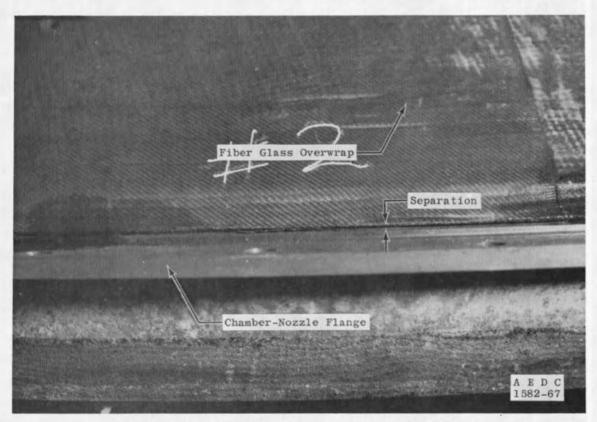
Fig. 13 Chamber Flange Separation (Phase V, S/N 324)

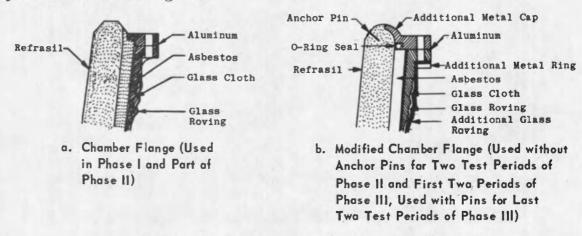
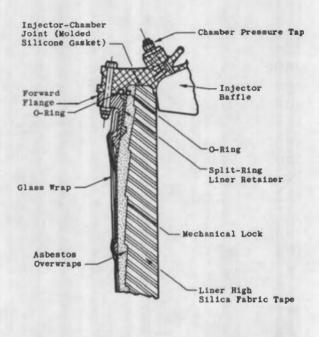
The various designs of chamber forward end (chamber/injector interface) which were tested are shown in Fig. 14. The original design for the injector/chamber flange (Fig. 14a) was used for all chambers in Phase I and all but the last four test periods of Phase II. About the middle of Phase II, after test period M, posttest inspection of the chamber (S/N 75) revealed delaminations of the ablative material at the injector seal area (Fig. 15).

Fig. 14 Combustion Chamber Flange Designs (Injector Interface)

d. Madified Chamber Flange (Used during First Three Test Periods of Phase IV)

e. Madified Chamber Flange (Used during Remaining Phase IV and All Of Phase V and VI Tests)

The only other change to the chamber design, to ensure the physical integrity of the interface seal, was the addition of a mechanical lock between the insulation and the ablative liner (Fig. 14e). This lock scheme was a series of steps at the interface of the insulation and ablative liner to prevent slippage of the ablative liner away from the injector. This design was satisfactory, and no further complications were encountered during Phases IV, V, and VI.

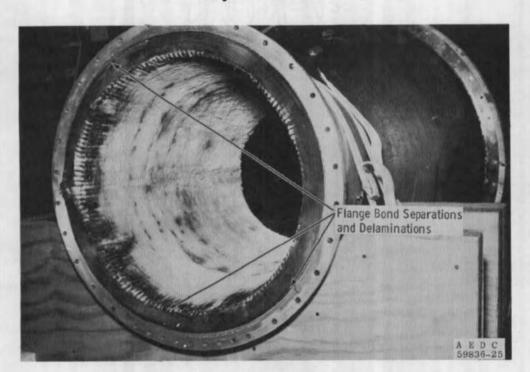
Fig. 15 Chamber S/N 75, Pastfire

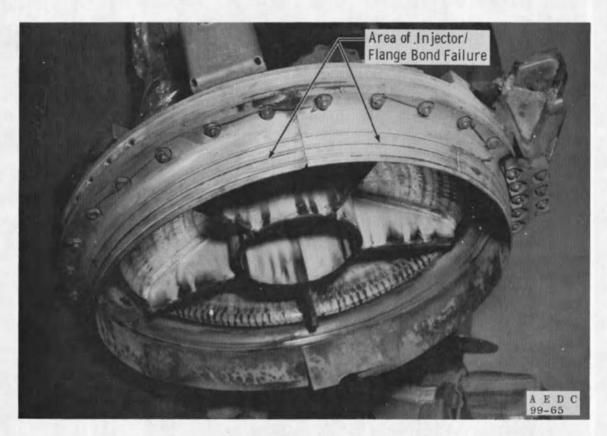
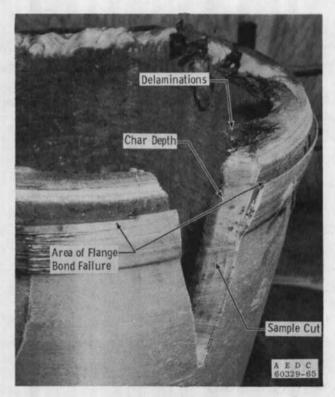
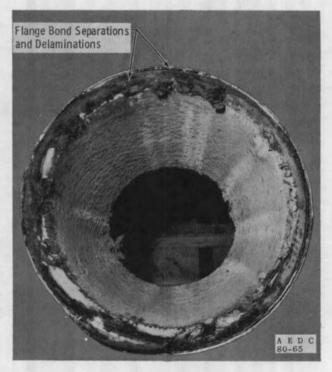
Test periods P, Q, R, and S, with chambers S/N 74 and 155 of the same design, revealed the severity of the problem with failures at the forward flange (Fig. 16a). These two chambers had operated for a total of 408 and 332 sec, respectively, of which 223 and 149 sec, respectively, were at the maximum chamber pressure (125 psia). Figure 16b shows chamber S/N 74 with a section removed and indicates the condition of the failure area. It was noted that the bond area was protected by virgin material in the radial direction, but the portion of the chamber that seals the joint of the injector flange was severely charred and eroded. Figure 16c is a top view of chamber S/N 155 showing the severity of erosion in the seal area. These delaminations of the ablative liner were suspected of contributing to, or perhaps even initiating, the flange-bond failures by permitting hot gas leakage behind the chamber/injector seal.

a. Engine S/N 11B Injector and Chamber Flange (S/N 155)

Fig. 16 Chamber Failures at Forward Flange Area

b. Chamber S/N 74

A chamber modification was made with additional glass roving to prevent flange movement, and the injector seal was redesigned to include an aluminum cap over the asbestos insulating layer and partially over the ablative liner as shown in Fig. 14b. An O-ring was added to prevent the flow of gas along the phenolic into the flange bond area. This modified chamber was tested for a total of 766 sec, of which 200 sec were at a chamber pressure of 125 psia and 355 sec at 110 psia. The chamber exhibited a notable improvement in durability over those previously tested even though posttest examination did reveal some delamination in the forward ablative liner and erosion of the metal cap (Fig. 17).

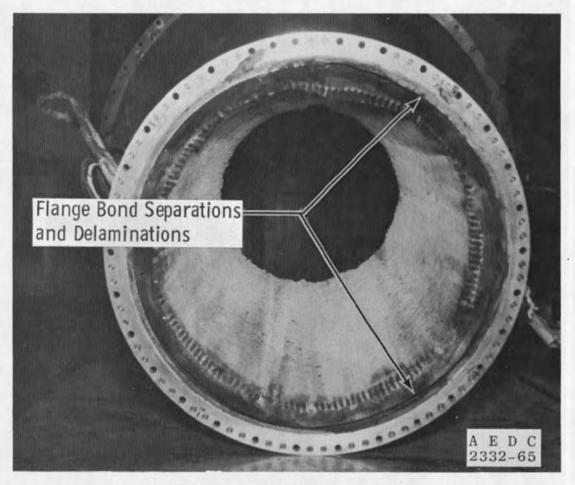
Fig. 17 Chamber S/N 208, Postfire, Injector End

To prevent delamination of the forward end, stainless steel pins were installed in the ablative liner to anchor the Refrasil material laminations (Figs. 14b and 18). Twenty-two pins were equally spaced

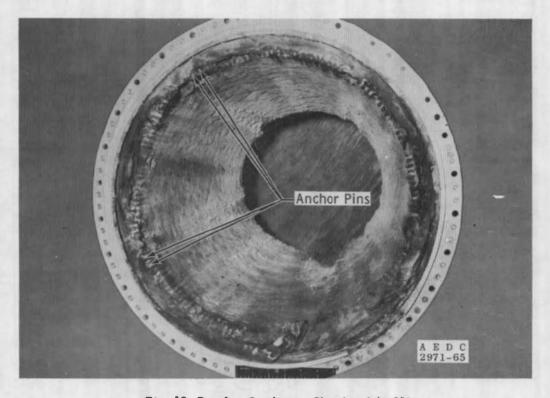
in two areas. Unpinned areas were left in between for comparison to aid evaluation of any improvement in interface durability. The test period for this chamber was discontinued short of completion because of high temperatures of the injector and chamber flanges. The total firing time was 501 sec, of which the final 278 sec were at 125-psia chamber pressure. Posttest examination revealed the same forward end delamination and showed that the anchor pins had not appreciably improved chamber interface durability (Fig. 19).

Fig. 19 Postfire Condition, Chamber S/N 211

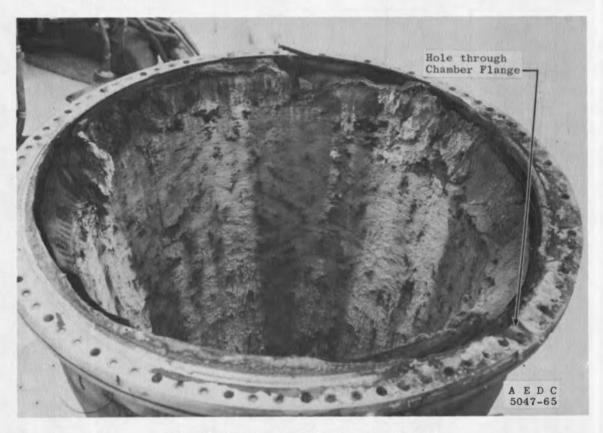
Fig. 24 Postfire Condition, Chamber S/N 213

After the test of chamber S/N 213, a new injector/chamber seal was devised with Refrasil and silicone rubber gaskets and silicone O-rings to seal the outboard surfaces of the flange, as shown in Fig. 14c. This seal performed satisfactorily as can be seen by comparing Figs. 22 and 23 with Figs. 25 and 26, which show temperatures obtained using the old-type seal (S/N 213) and corresponding data graphs for the new seal (chamber S/N 222). Test durations were the same, but temperatures with the new seal were considerably lower during the long firings. Figure 27 is a postfire view of the chamber on which the new-type seal was used. This new chamber/injector seal was used on the remainder of the chambers tested in Phase III and performed satisfactorily until the final test period. The final test period of Phase III consisted of long-duration firings at high combustion chamber pressure (110 psia). Figures 28 and 29 are temperature-time graphs of the injector flange temperatures from these firings and show the increasing flange temperatures, which were indicative of incipient failure. This engine was not disassembled prior to shipment; therefore, no postfire photographs are available. This completed the testing of the Block I chamber.

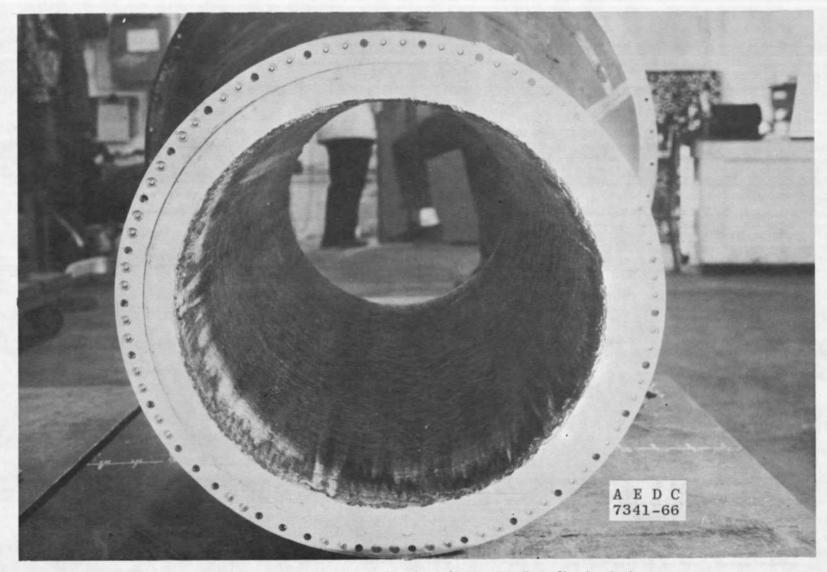
Fig. 27 Postfire Condition, Chamber S/N 222, New-Type Chamber Seal

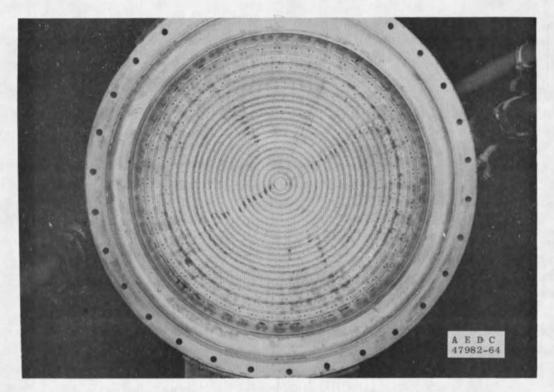
Fig. 30 Unbaffled Doublet Injector, View Looking Upstream

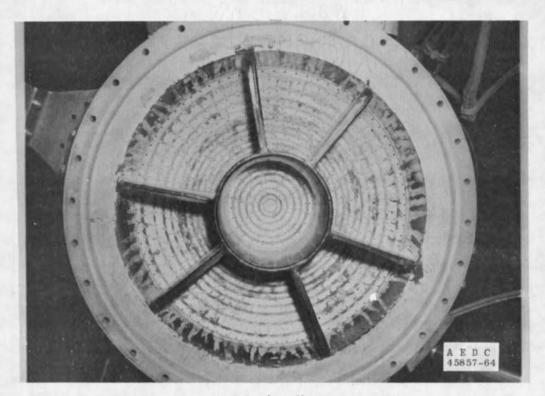
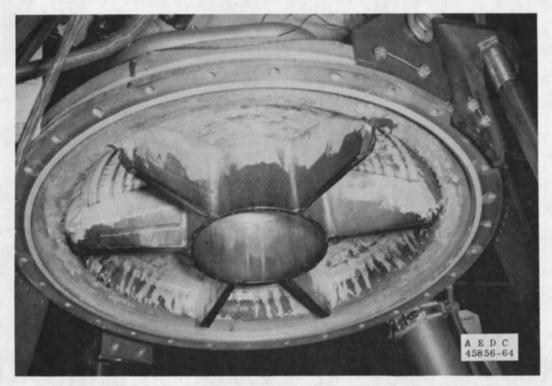
Fig. 31 Baffled Doublet Injector

The last injector tested in Phase I was the baffled doublet configuration, S/N BF-18 (Fig. 31). This injector was tested for a total of 379 sec in test series A-06 (7 firings), which included one firing of 260 sec. The injector performed satisfactorily with no CSM shutdowns. Postfire inspection revealed no abnormalities of the injector, but three longitudinal "streaks" occurred on the chamber wall, two of which extended to the throat (Fig. 35). These streaks were not in line with the baffles and were not attributed to the wake from the baffles.

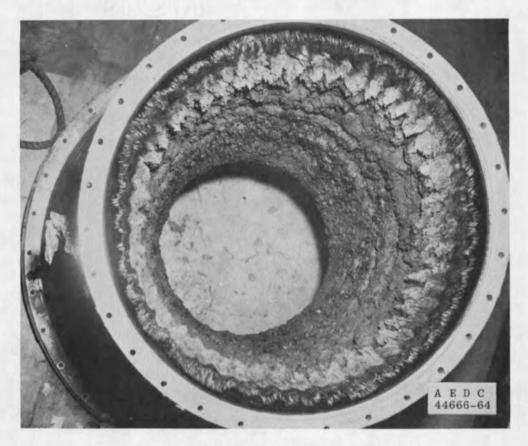
Fig. 33 Combustion Chamber Ablation and Melting

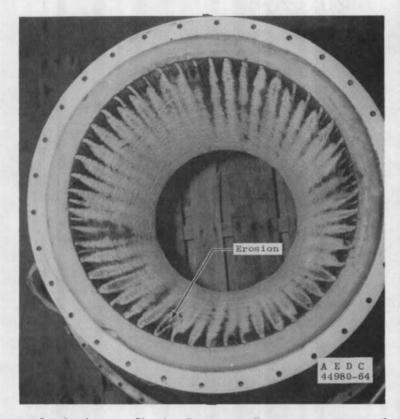
The last unbaffled doublet injector tested in Phase I was S/N AFF-23. At the completion of test C-01-1, an inspection showed that the injector was in good condition but that the chamber was severely eroded as shown in Fig. 34. This condition indicated an abnormal mixing pattern because this type of erosion was not present with the other injectors of this configuration. However, when this injector was tested again during tests C-03 (firings 1-21) and C-04 (firing 1-8), there was no evidence of chamber erosion; included was one firing of 635 sec (C-04-6). There was one CSM shutdown, 0.6 sec after ignition during firing C-04-4. No other difficulties were encountered.

Fig. 34 Combustion Chomber Domage on Engine Assembly No. 2

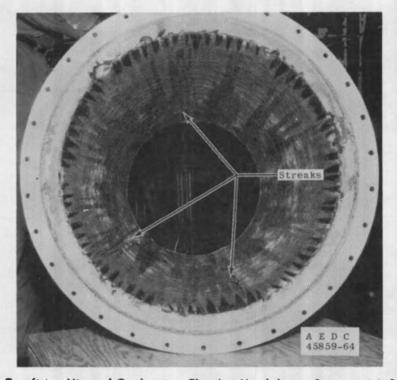
Fig. 35 Postfiring View of Combustion Chomber Used during Series A-06, S/N A-1

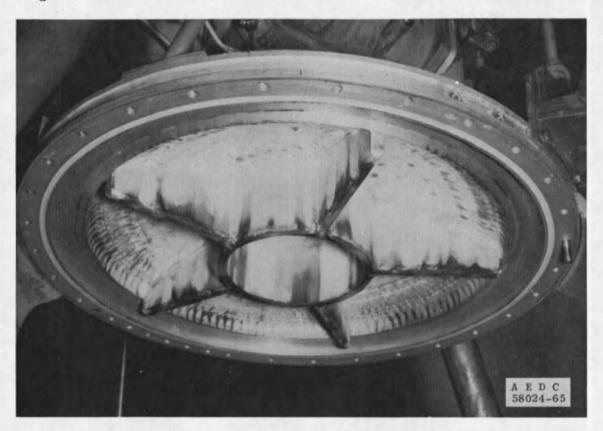
During Phase II, five different injectors were used; all were the doublet impingement type; one was unbaffled, and the other four were baffled. The unbaffled injector was similar to those of Phase I, but the baffled type had five radial baffles instead of six, as used previously (Fig. 36).

Fig. 36 Baffled Injector

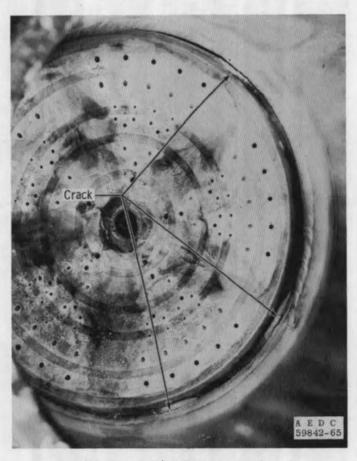
These injectors performed satisfactorily with the exception of S/N 91 which developed a crack in a weld adjacent to the cylindrical baffle (Fig. 37). This condition had been anticipated by AGC, and corrective measures were taken with the welding process. The baffled injectors caused no CSM shutdown during this phase. To induce combustion instability and document the suppression ability of the injector, a pulse charge (bomb) was placed on the injector face prior to each test period. The pulse charge was a No. 8 blasting cap plus 2.46 gm of C-4-type explosive in a Teflon® holder, which was screwed into the center of the injector face (Fig. 38). The pulse charge was located about 6 in. downstream of the injector face, and charge ignition was by combustion heat. A typical firing thrust/time history, showing the detonation and recovery of the thrust to normal, is shown in Fig. 39.

Fig. 37 Engine S/N 11A Injector, Postfire

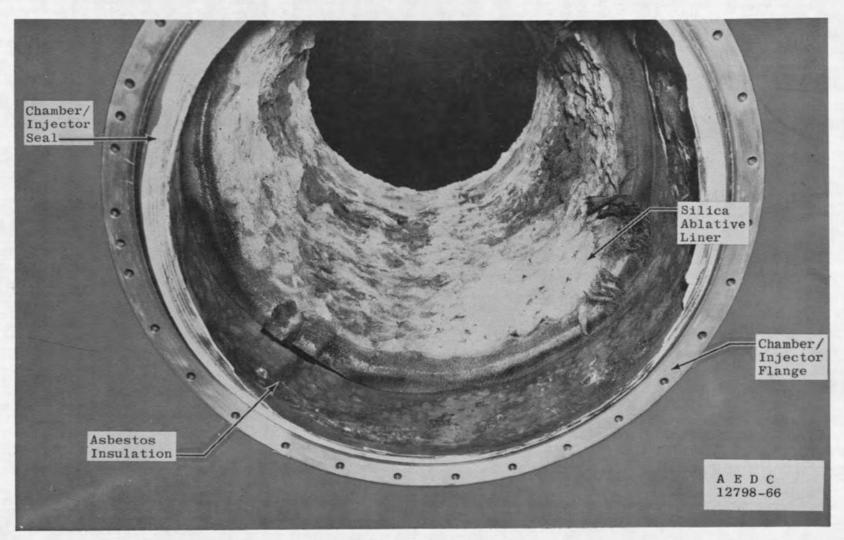
Fig. 41 Postfire Chamber S/N 261

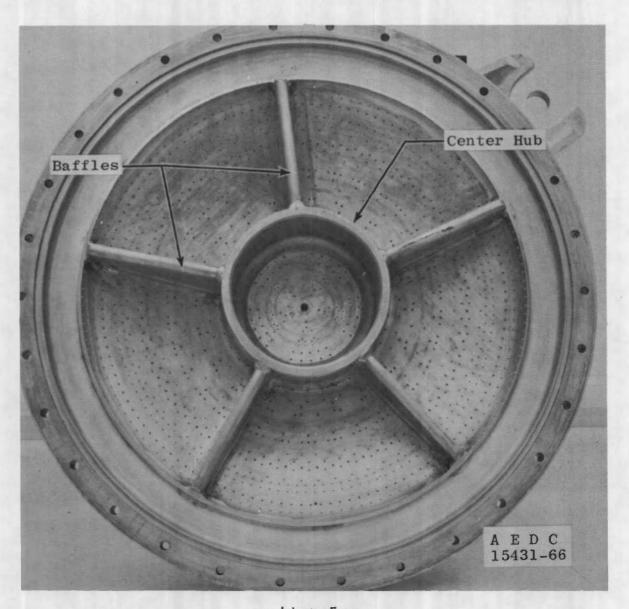
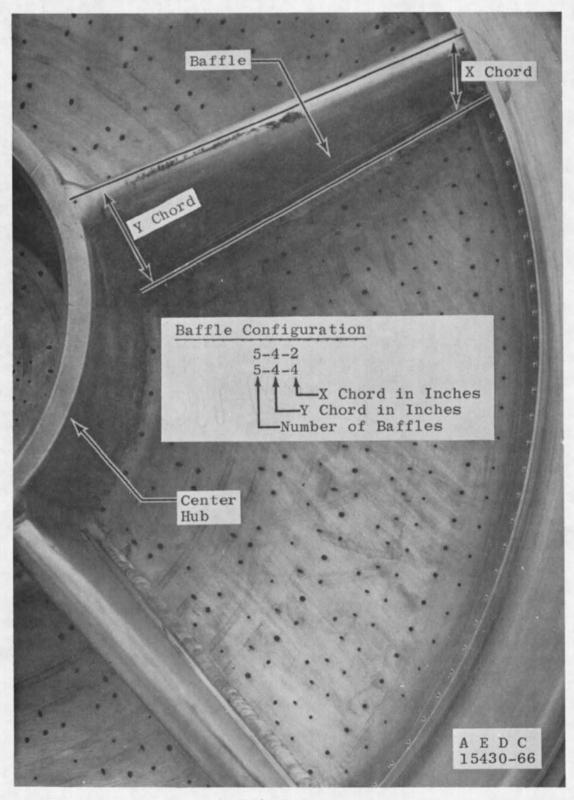
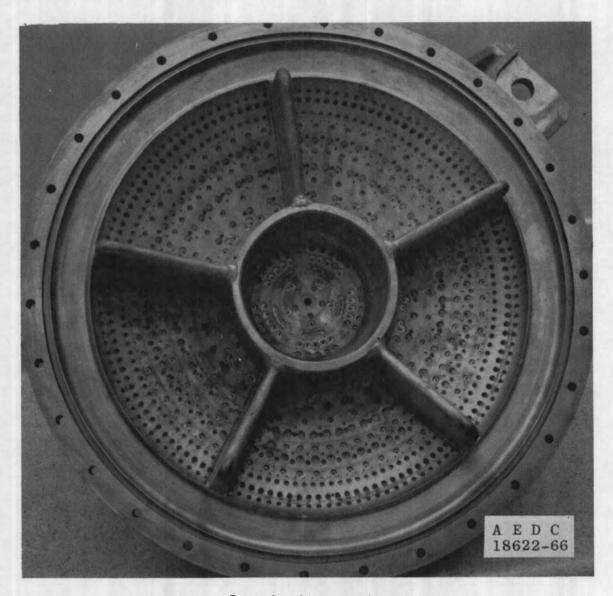
a. Injector Face
Fig. 42 Baffled Injector

b. Baffle Configuration Fig. 42 Continued

c. Counterbored Injector S/N 105 Fig. 42 Concluded

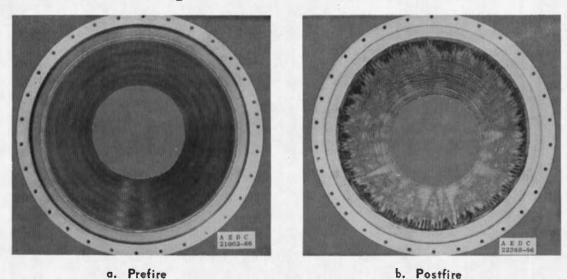
All injectors performed satisfactorily. There was no evidence of combustion pops, the chamber compatibility was good, and there was little ablation evident when comparing prefire and postfire conditions of the chamber interiors (Fig. 43).

Fig. 43 Typical Combustion Chamber

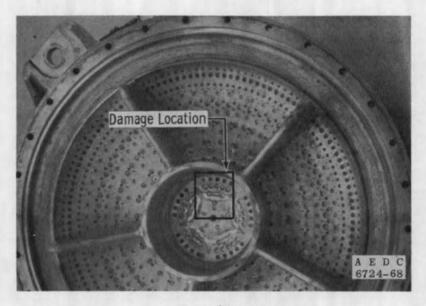
Injector operation, performance, and chamber compatibility were satisfactory. During the research testing of the ignition characteristics of injector S/N 98, some of the oxidizer injection ports were damaged in the center hub section as shown in Fig. 44. The cause of the damage was not identified; a careful survey of the data did not reveal any unusual occurrences which would have caused such damage. The orifice deformation had no noticeable effect on engine performance and operation.

a. Area of Damage

b. Close-Up View
Fig. 44 Injector Damage after Ignition Testing, Phase VI
